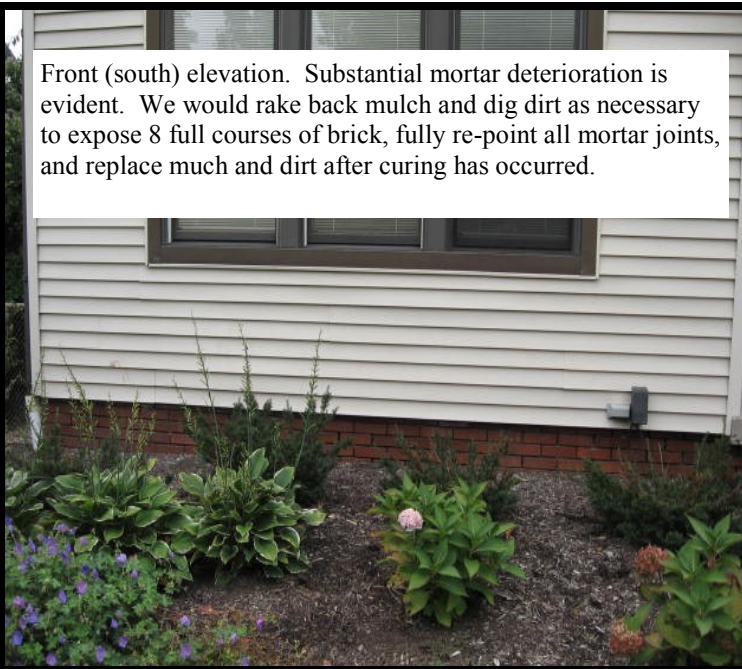
Front (south) elevation. Substantial mortar deterioration is evident. We would rake back mulch and dig dirt as necessary to expose 8 full courses of brick, fully re-point all mortar joints, and replace mulch and dirt after curing has occurred.

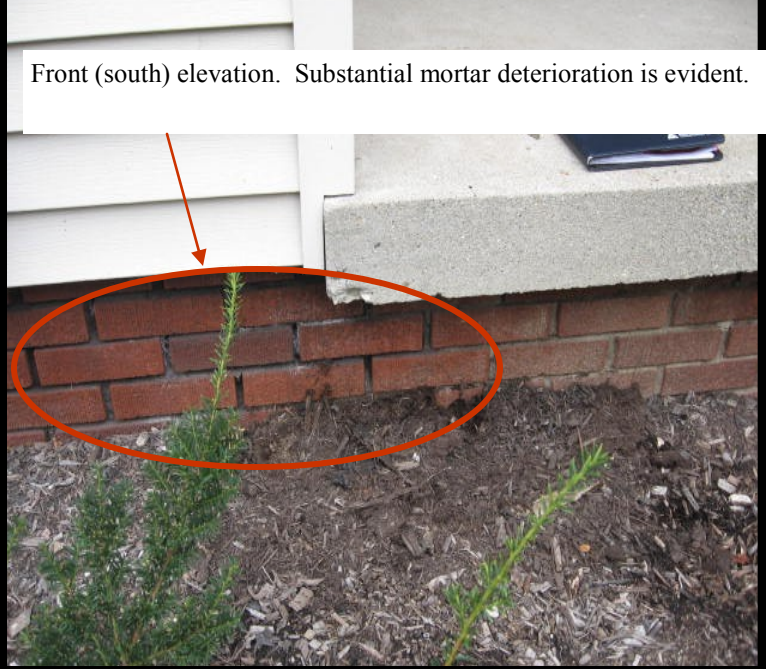
Front (south) elevation. Substantial mortar deterioration is evident.

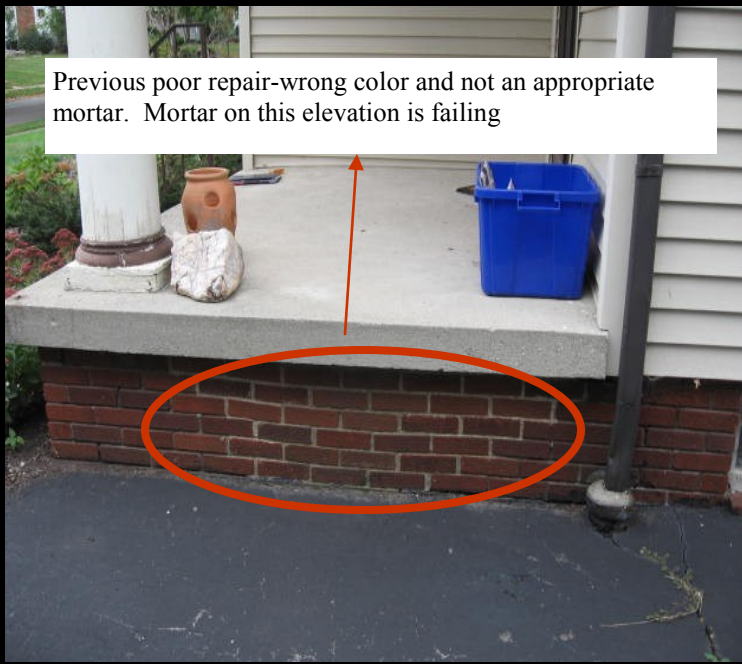
Previous poor repair-wrong color and not an appropriate mortar. Mortar on this elevation is failing

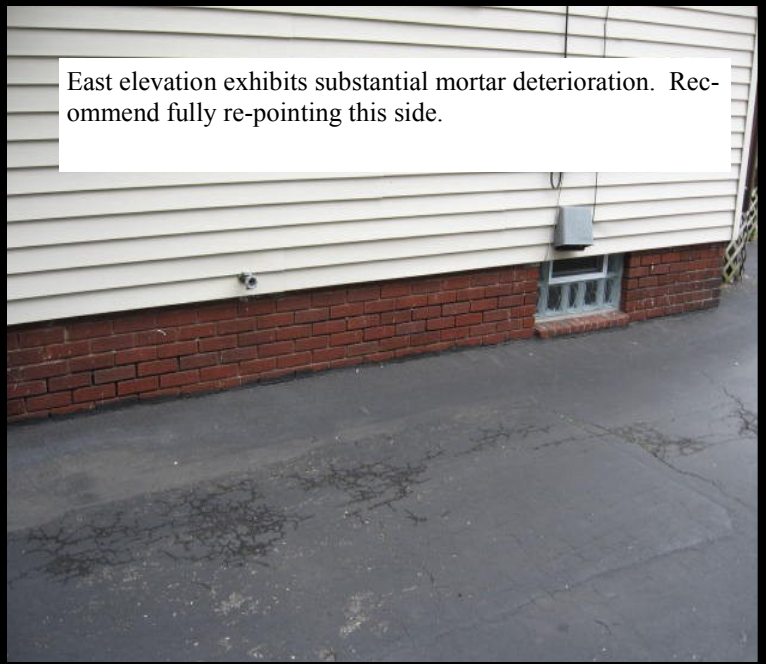
East elevation exhibits substantial mortar deterioration. Recommend fully re-pointing this side.

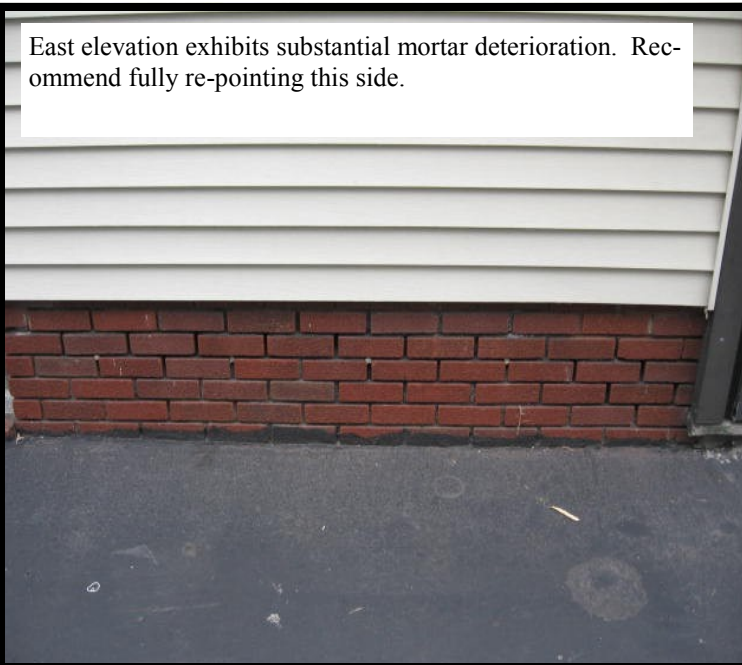
East elevation exhibits substantial mortar deterioration. Recommend fully re-pointing this side.

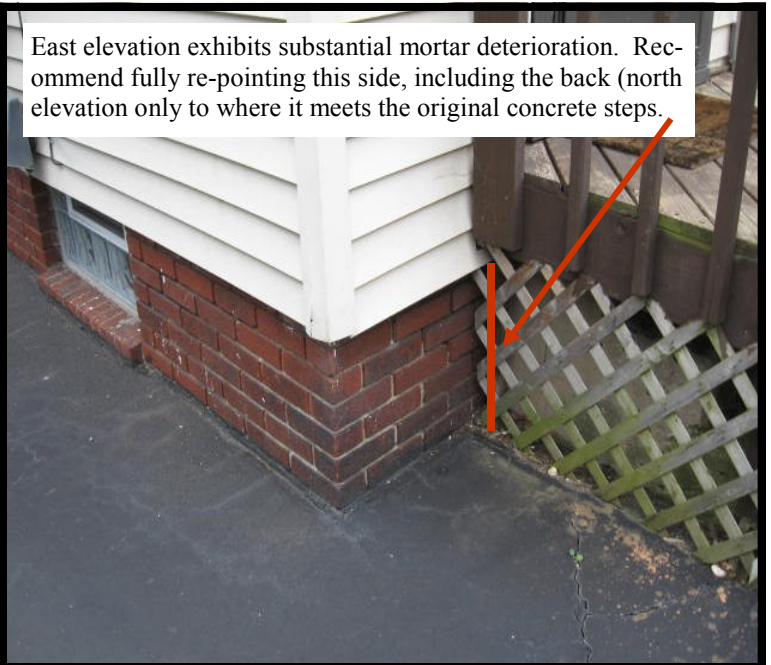
East elevation exhibits substantial mortar deterioration. Recommend fully re-pointing this side, including the back (north elevation only to where it meets the original concrete steps.

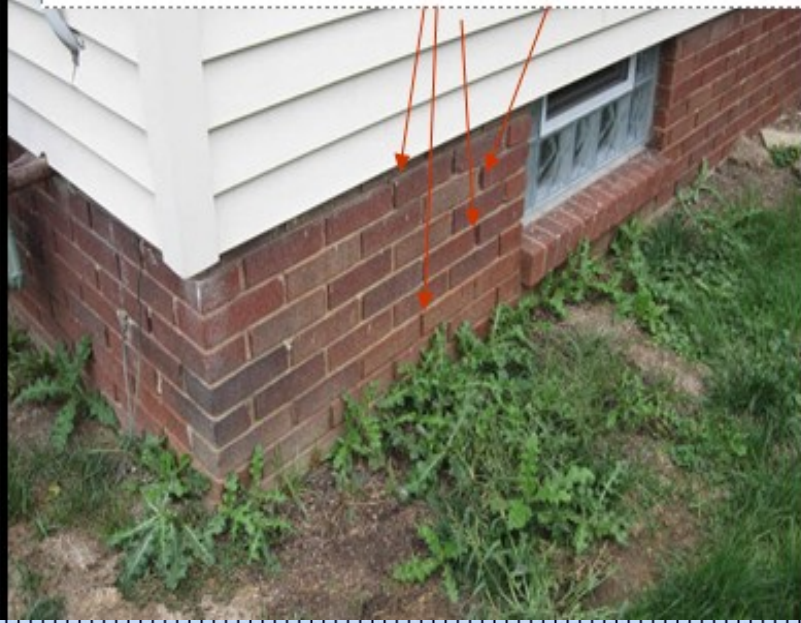
Northwest corner of home example of empty joints that would be

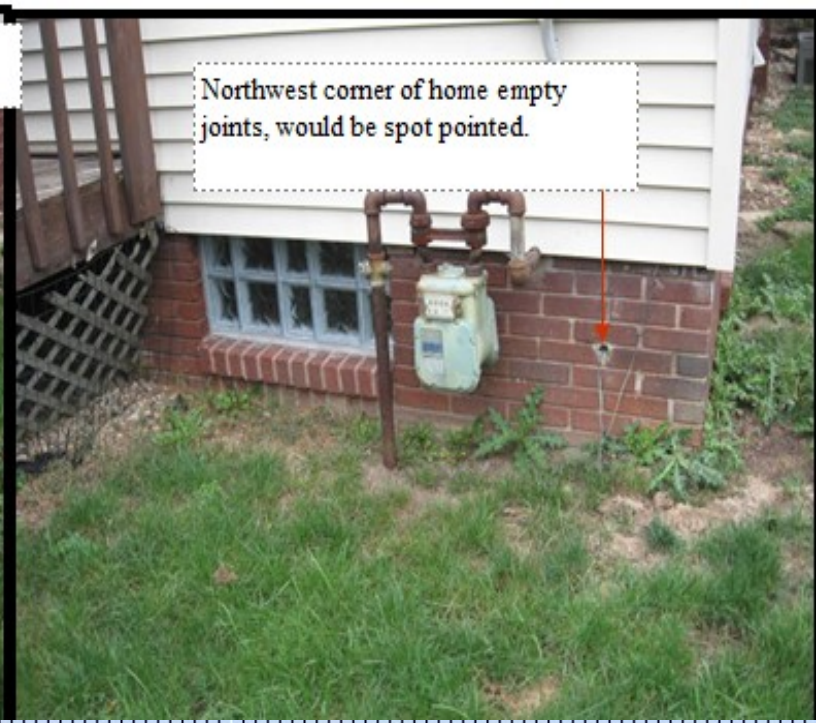
Northwest corner of home empty joints, would be spot pointed.

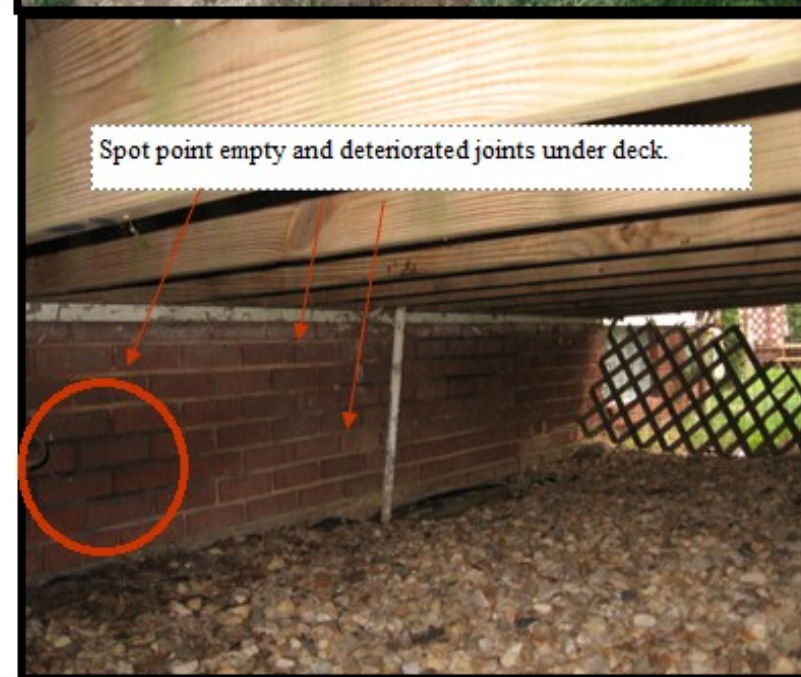
Spot point empty and deteriorated joints under deck.

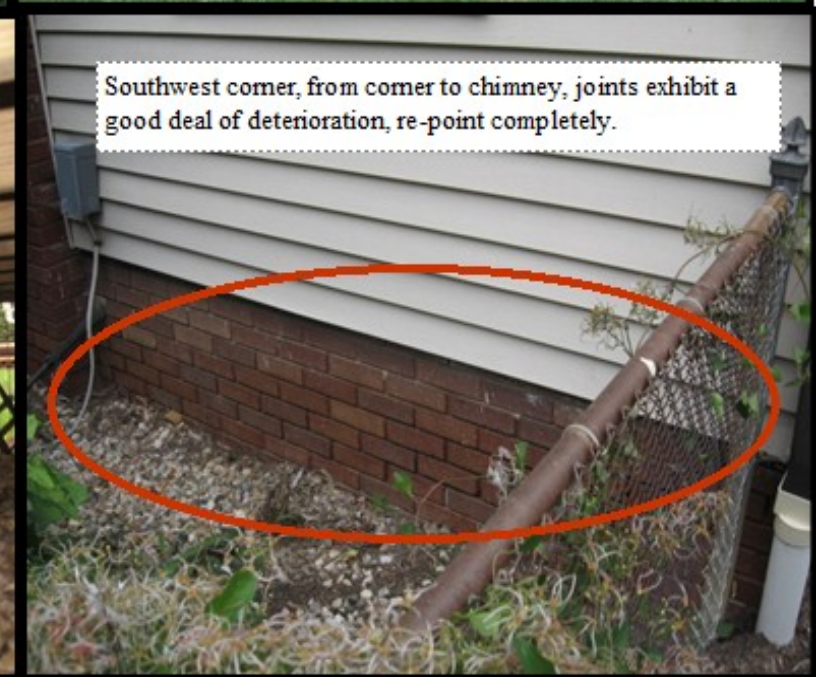
Southwest corner, from corner to chimney, joints exhibit a good deal of deterioration, re-point completely.

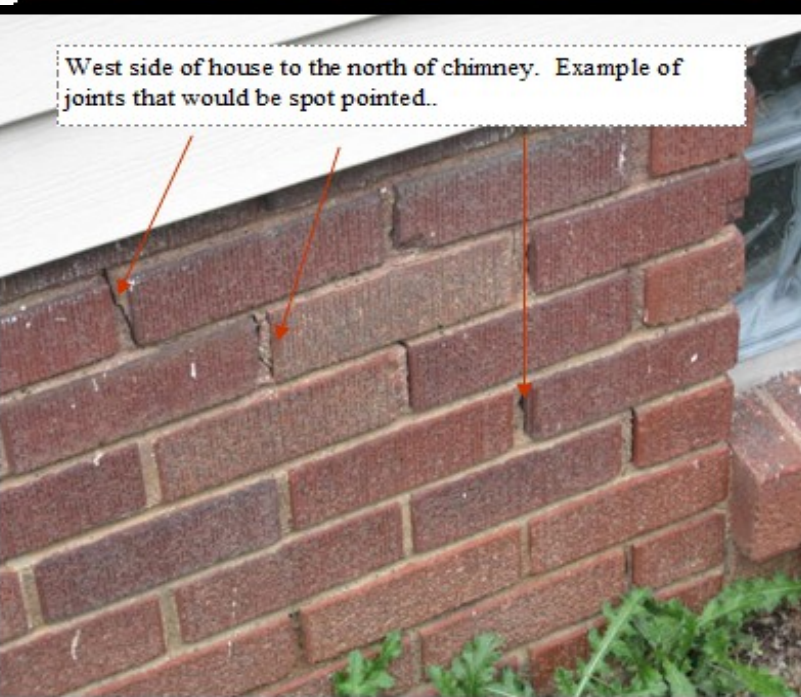
West side of house to the north of chimney. Example of joints that would be spot pointed.

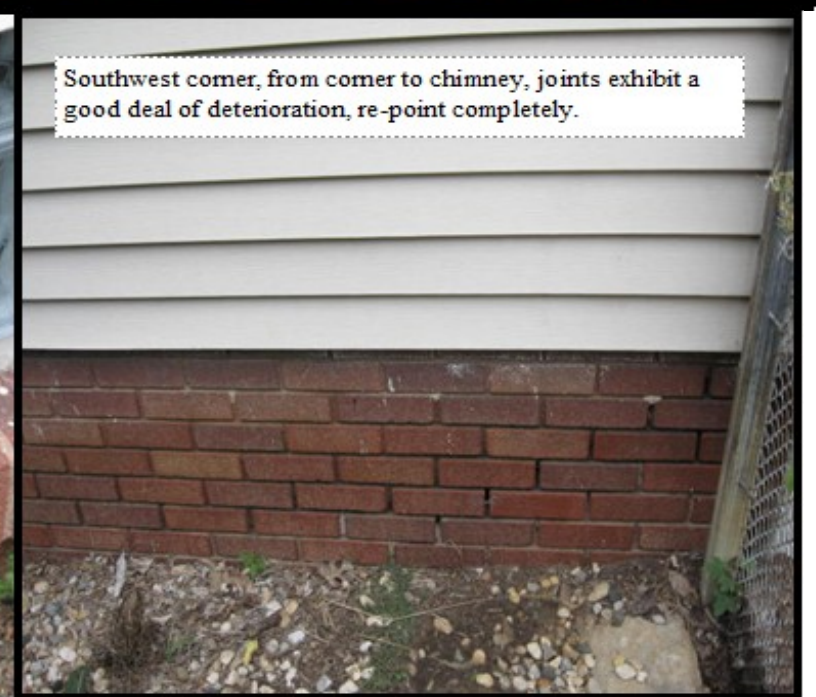
Southwest corner, from corner to chimney, joints exhibit a good deal of deterioration, re-point completely.
